**Trailhead Irrigation and Driving Range Workshop**

## **TRAILHEAD GOLF COURSE SITE VISIT REPORT**

This report documents the findings of our recent evaluation of the irrigation system at Trailhead Golf Course. The purpose of this site visit was to evaluate the current condition of the irrigation system and recommend any necessary upgrades. The site visit was made over two days, September 12 and 13, 2017.

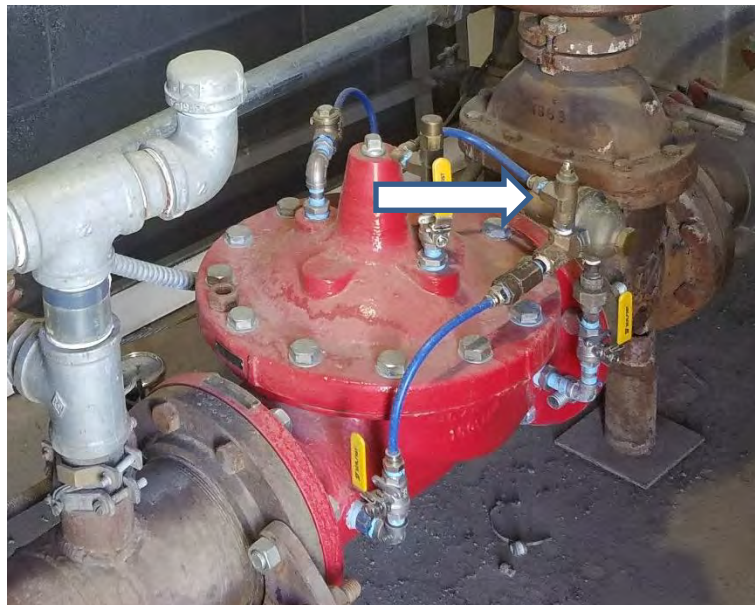
The pump control valve appears to be in good condition, however we noticed that it only has a pressure reducing control valve in the pilot system. It also needs to have a pressure relief control valve in the pilot system to prevent surge pressures from entering the irrigation system. It should also have opening and closing speed controls if it doesn't have them already. The arrow in the photo to the right points to the pressure reducing control valve. The pressure relief valve looks very similar and would be on the opposite side of the main valve body.

We recommend regularly scheduled service of the control valve since it controls the pressure that is ultimately seen in the irrigation system. Twice a year is a good idea; once a year should be considered to be the minimum service interval.

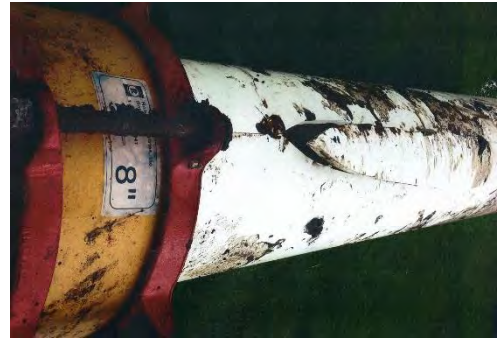
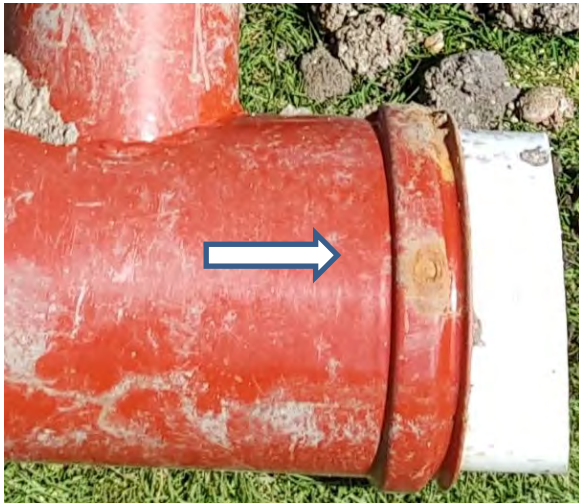
short order. This can produce a significant amount of water hammer in the system. We can only estimate the degree of the pressure surge, but suffice it to say it has been significant. In the last two years, there have been approximately 8-10 main line breaks, primarily for broken main line pipe. Additional repairs have been made for significantly leaking fittings. We were provided photos of the last main line break that was repaired. The pipe was split along the entire length and continued for two lengths of pipe for about 40'. This is more than likely damage from water hammer. At this point, the entire main line system has been compromised and future breaks are certain to occur, but it is impossible to predict when or where. From past experience, we would expect the frequency of these breaks to increase over time.

Some of the main line repairs have been made to repair leaks at the fittings where the lateral valves are attached to the main line pipe. These appear to be steel fittings. We are uncertain of the brand, but this type of fitting is no longer in use in the golf or waterworks industry due to frequent failures caused by corrosion. The arrow in the photo to the left points to what appears to be corrosion through the body of the fitting at the gasket location. The current standard is to use ductile iron fittings which are much more substantial. These are available with epoxy coating to

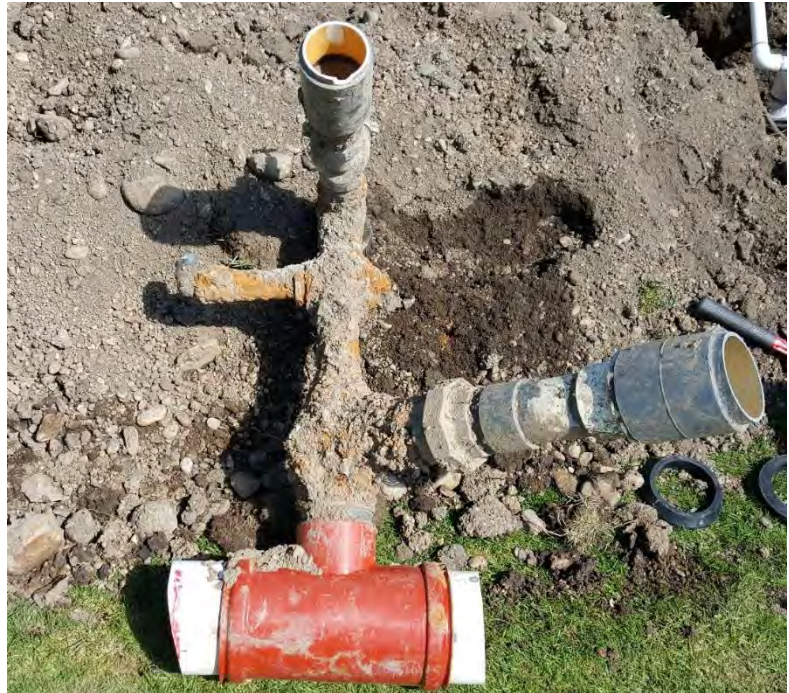
The original valves were made of brass or bronze; however, they were plumbed to the main line using galvanized steel pipe and fittings. By using dis-similar metals without a di-electric union between them, a galvanic response occurs which essentially turns the connection into a battery. In this combination of metals, the brass or bronze stays mostly intact but the galvanized steel will corrode. Over time, the corrosion will be substantial enough to eat completely through the galvanized pipe and make the threaded connection between the two metals virtually inseparable. Leaking connections are inevitable. This is indeed what has been happening and a significant number of the valve assemblies have been replaced. The newer valves that are being installed are made of thermoplastic rather than brass, so the galvanic response is eliminated in the new assemblies.

We recommend that replacement continue on an as needed basis, but that all future valves be purchased with the pressure regulation feature. Note that the pressure regulation feature can be added to the newer RCV's that have already been installed and we would recommend making this upgrade if you elect to not replace these valves in the near future.

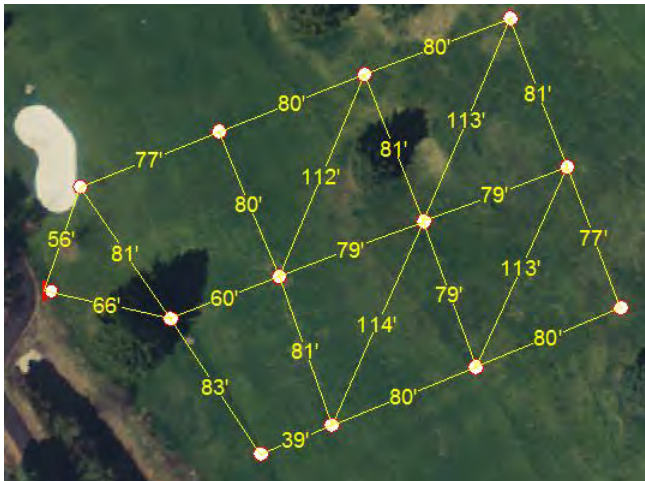
SPRINKLER SPACING  
HOLE 1 FAIRWAY

The course was originally designed with Rain Bird model 47 (part circle) and 51 (full circle) impact sprinklers at 80' square spacing. We confirmed the spacing using GPS equipment and found it to be fairly consistent between 77' and 82'. The maintenance staff was under the impression that spacing was inconsistent, but we found it to be fairly consistent with the original design intent. We are assuming that their impression came from measuring across the square in which case you will measure approximately 113'. As you can see from the measurements on Hole 1 below, some spacing was adjusted because of trees and golf features such as bunkers, but overall, it seems to be fairly true to the original intent. The lower left measurement on Hole 1 fairway appears to be an anomaly; there may have been a tree behind that sprinkler at one point in time.

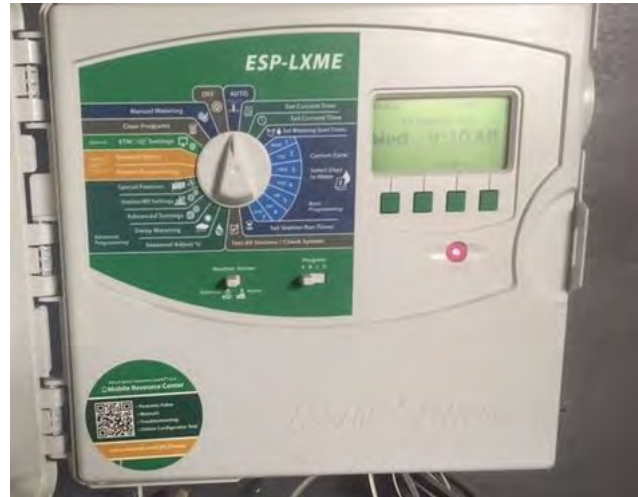
The indoor location of the field controllers does not lend itself to convenient use for starting sprinklers from the field. However, using the features of the IQ central control system, the maintenance staff can activate sprinkler zones from a smart phone or tablet connected to the internet.

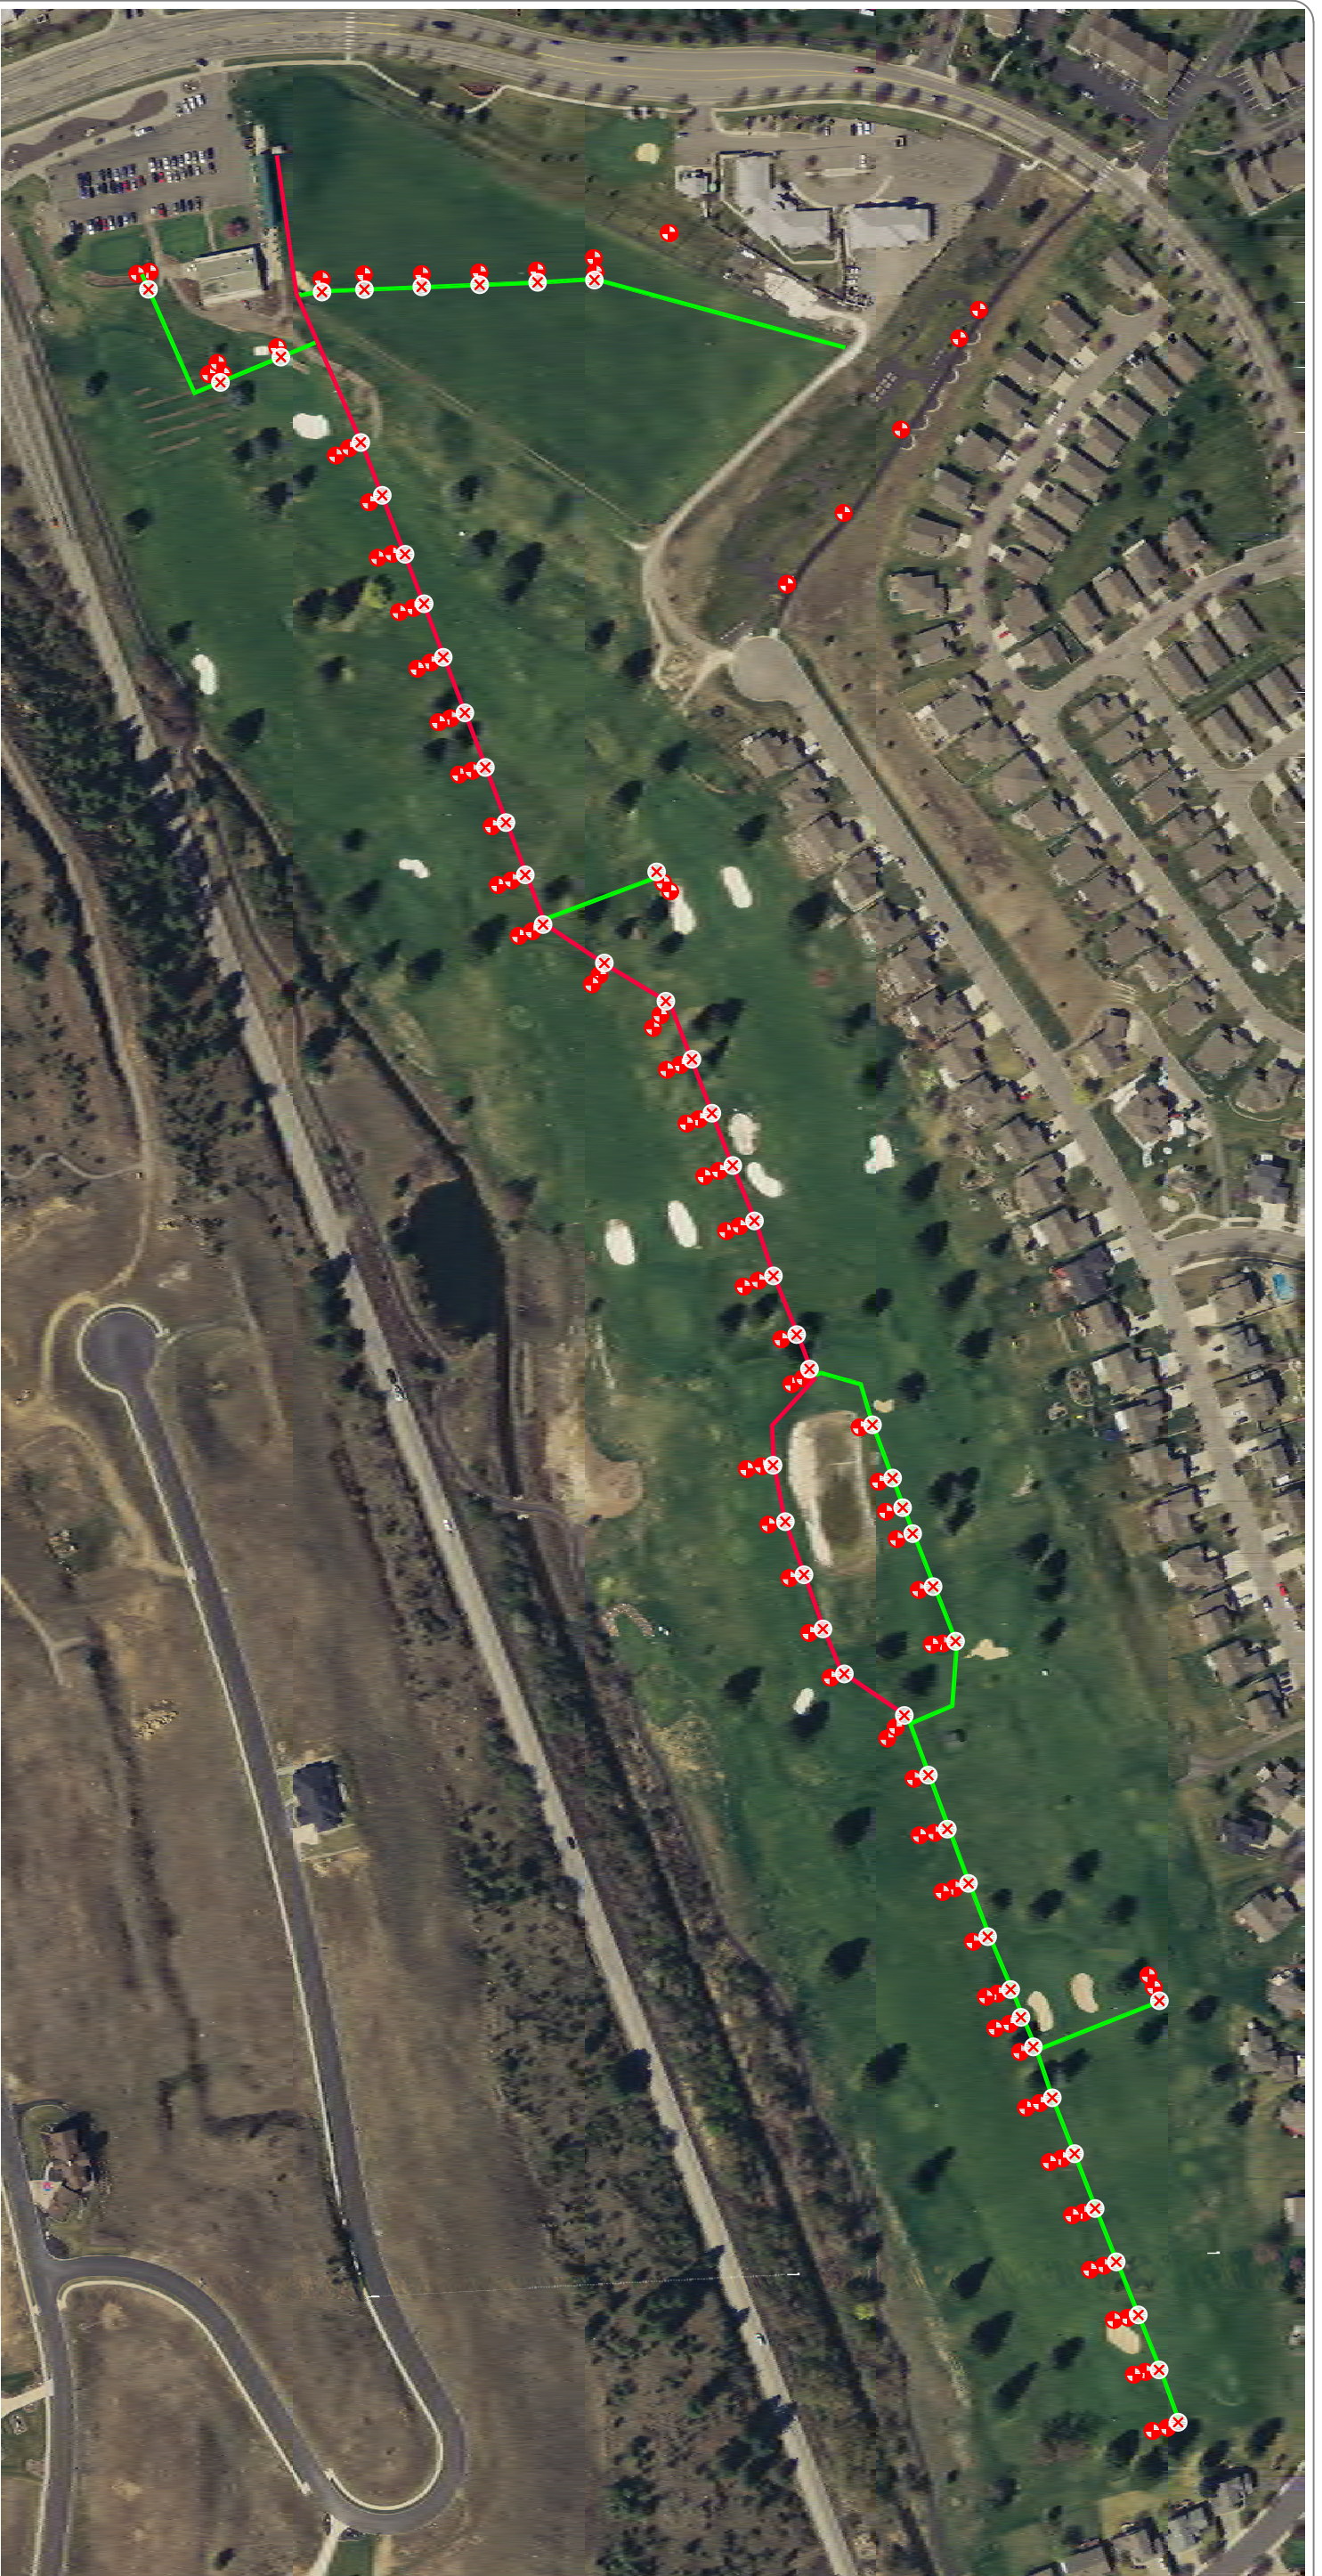
### SCHEMATIC OF PROPOSED MAIN LINE REPLACEMENT

A sketch of the suggested new main line installation is attached for reference as Attachment 2. We would recommend using only 8" and 6" pipe to improve flows and reduced pressure losses. At prevailing wage rates, and including a 10% contingency, we estimate this work will be in the vicinity of \$300,000-\$350,000.

We will address other options in the next section, but at a minimum, replacement of the main line would entail trenching in new pipe, installing lateral isolation valves for each set of block valves, and piping over to the existing valves (or moving the existing valves to the new main line). New main line would be installed offset approximately 10' from the current main line. With the installation of a new main line, it would be appropriate to install all new remote control valves that include pressure regulation.

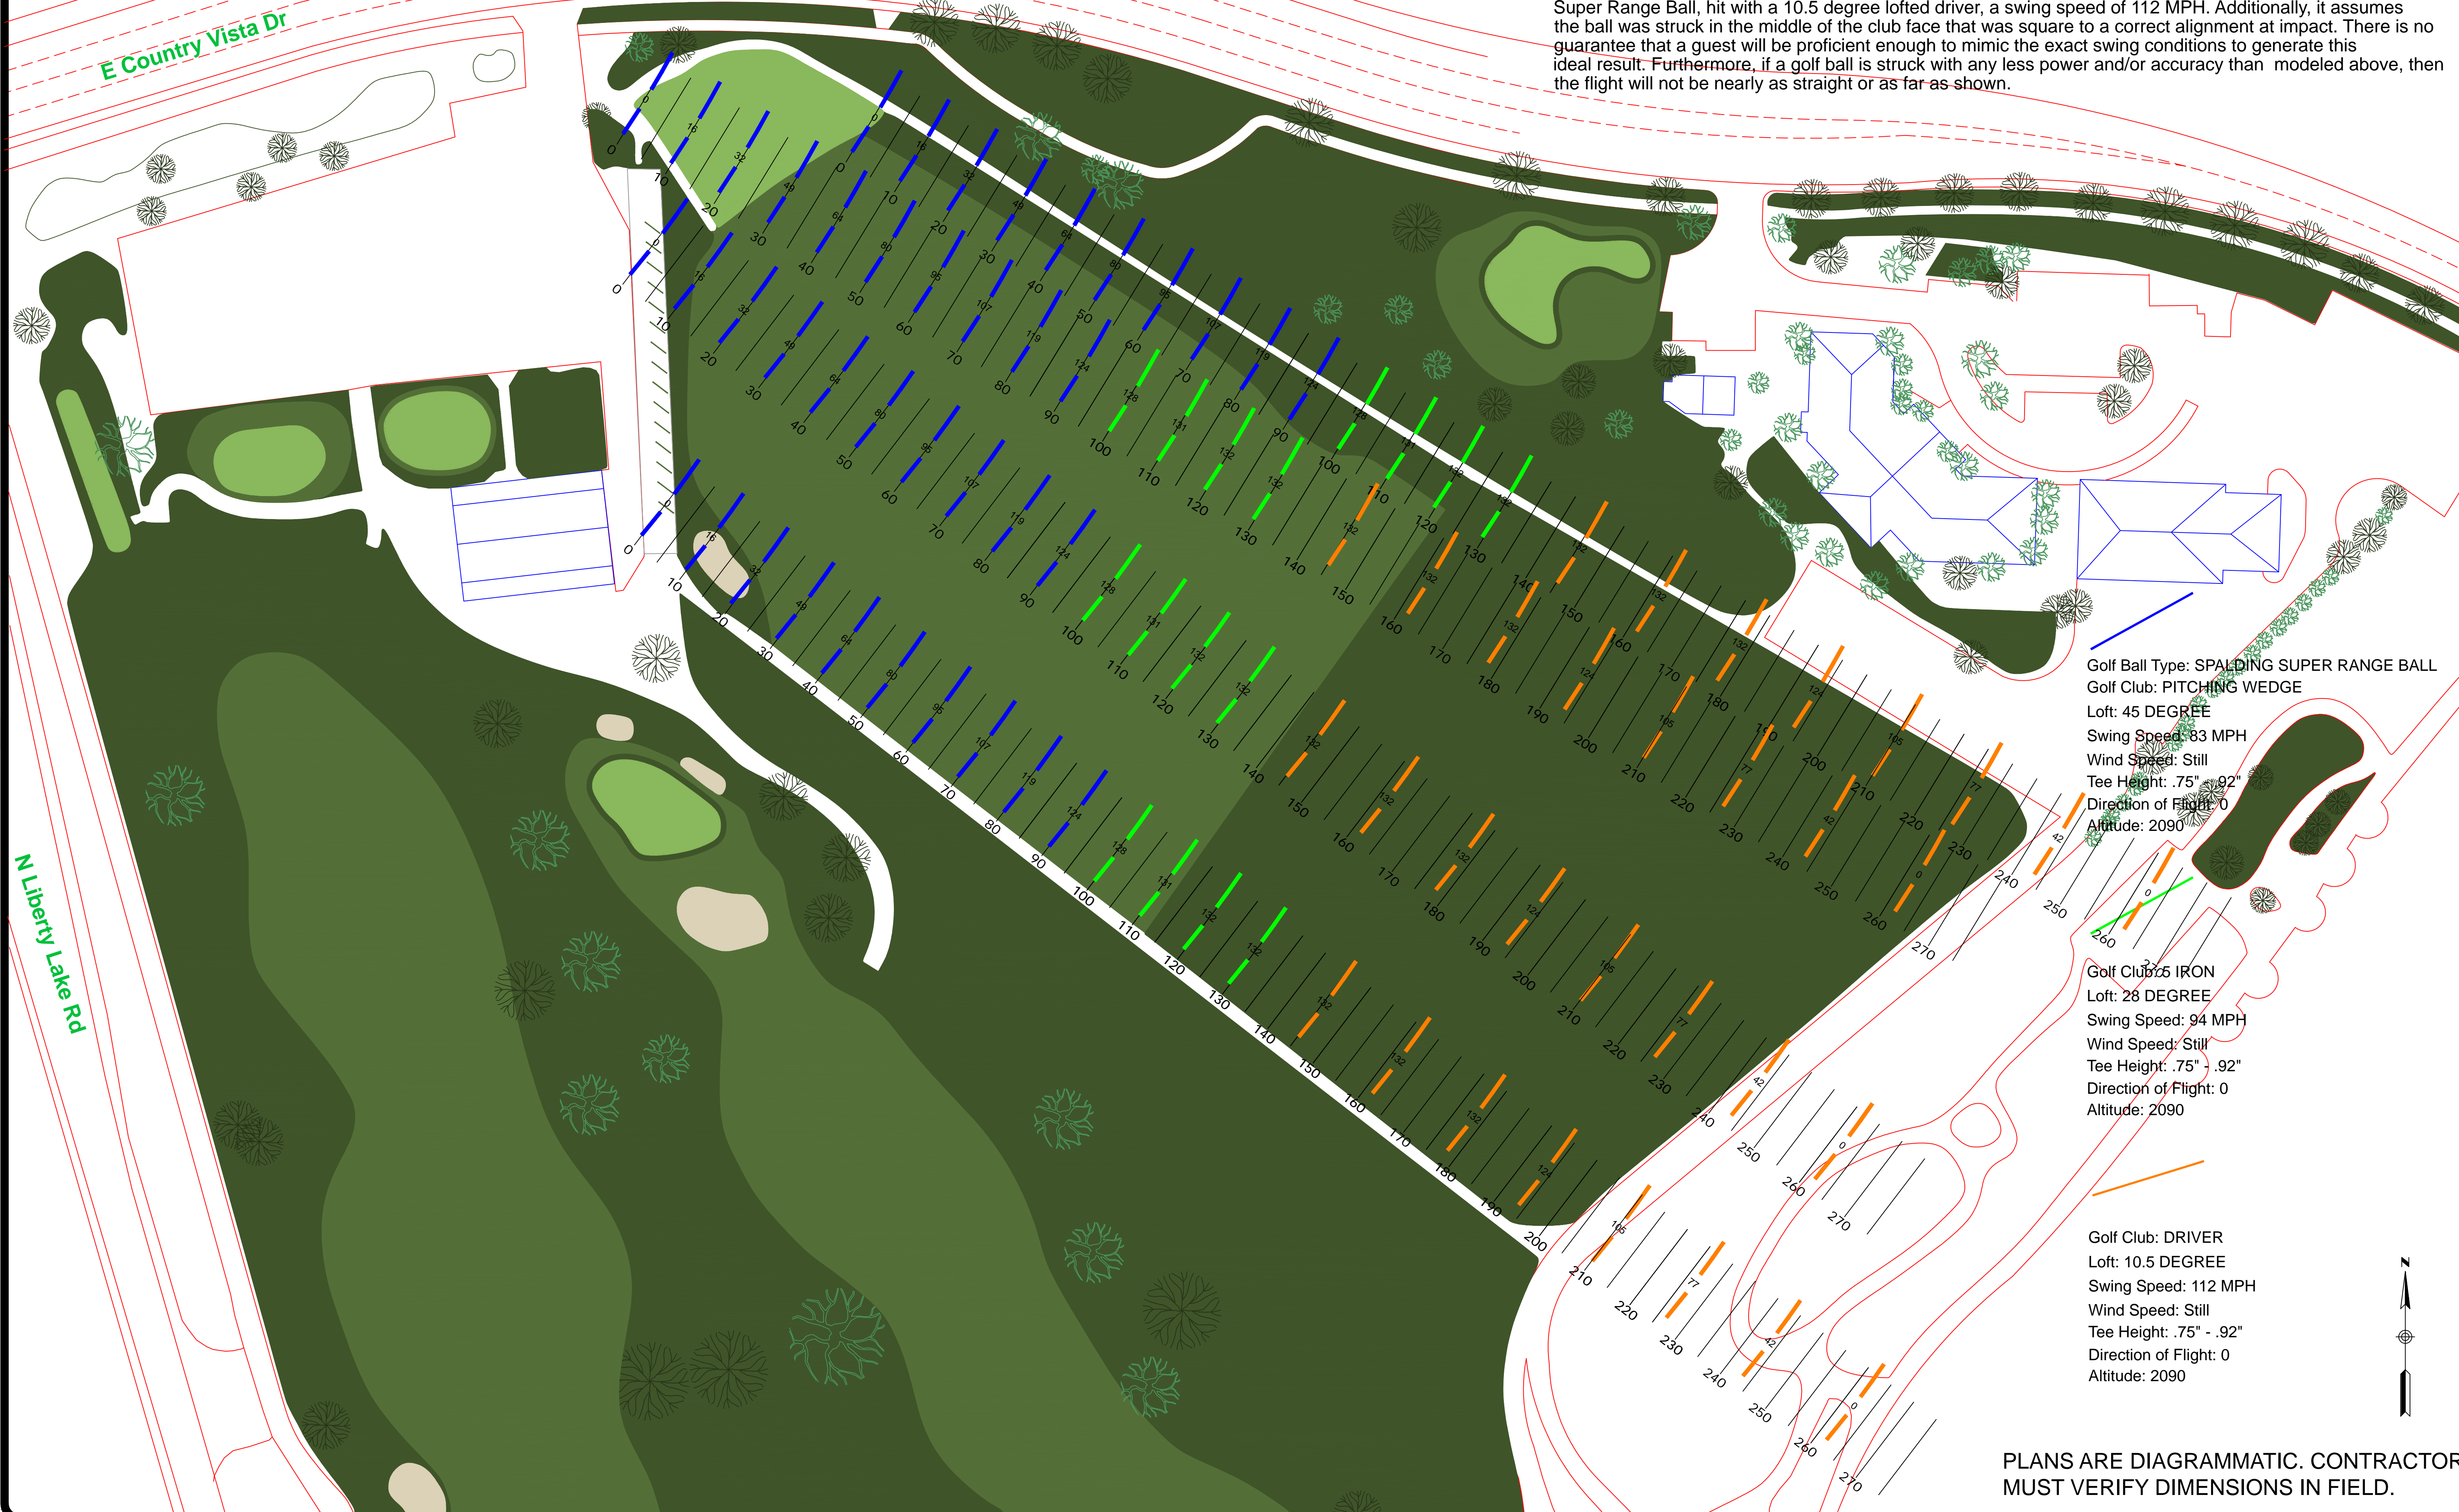
For the purpose of this study, this illustration prepared by Tanner Consulting Group depicts the path of a Spalding Super Range Ball, hit with a 10.5 degree lofted driver, a swing speed of 112 MPH. Additionally, it assumes the ball was struck in the middle of the club face that was square to a correct alignment at impact. There is no guarantee that a guest will be proficient enough to mimic the exact swing conditions to generate this ideal result. Furthermore, if a golf ball is struck with any less power and/or accuracy than modeled above, then the flight will not be nearly as straight or as far as shown.

Golf Ball Type: SPALDING SUPER RANGE BALL  
 Golf Club: PITCHING WEDGE  
 Loft: 45 DEGREE  
 Swing Speed: 83 MPH  
 Wind Speed: Still  
 Tee Height: .75" -.92"  
 Direction of Flight: 0  
 Altitude: 2090

Golf Club: IRON  
 Loft: 28 DEGREE  
 Swing Speed: 94 MPH  
 Wind Speed: Still  
 Tee Height: .75" -.92"  
 Direction of Flight: 0  
 Altitude: 2090

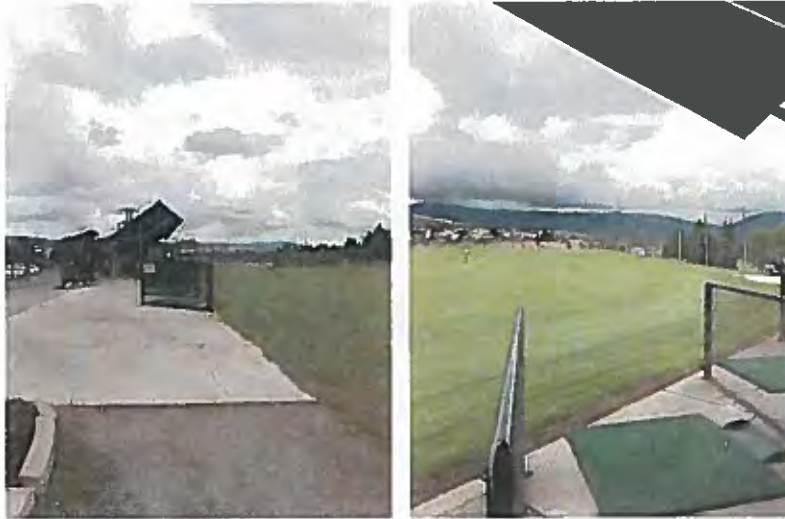
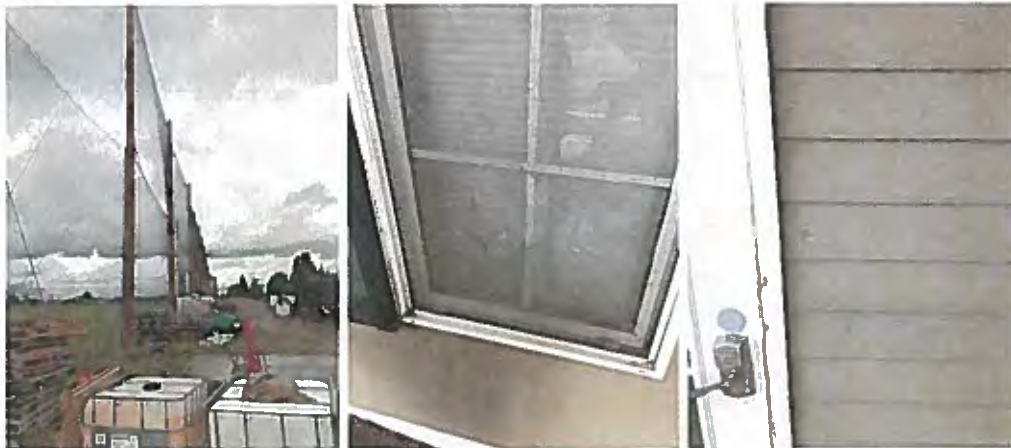
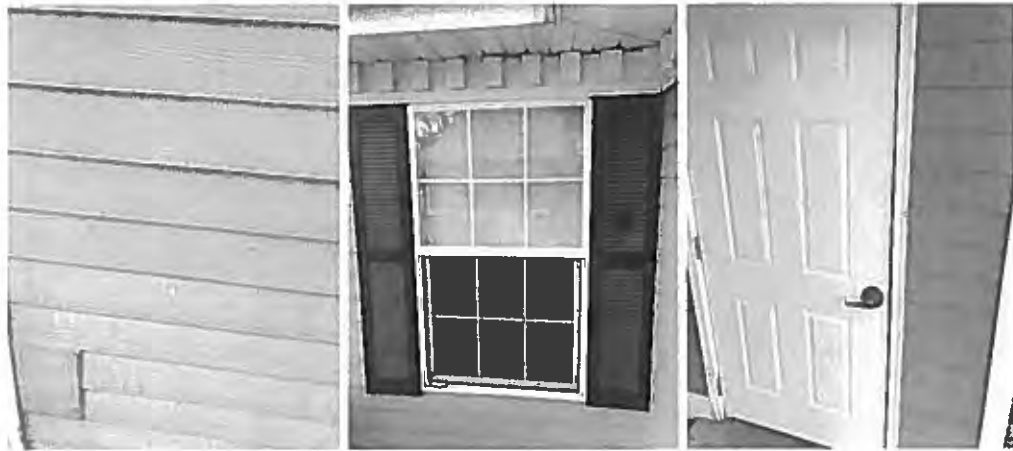
- A. Conditions that need to be remedied by City personnel as soon as the City can address this issue.
1. The height of the fencing on the left of the driving range is low, allowing golf balls to be hit over the fencing, which can result in damage to City buildings as well as cars parked in the area. Apparently, there have been multiple broken windows, and there is also visible damage to the siding on the buildings.

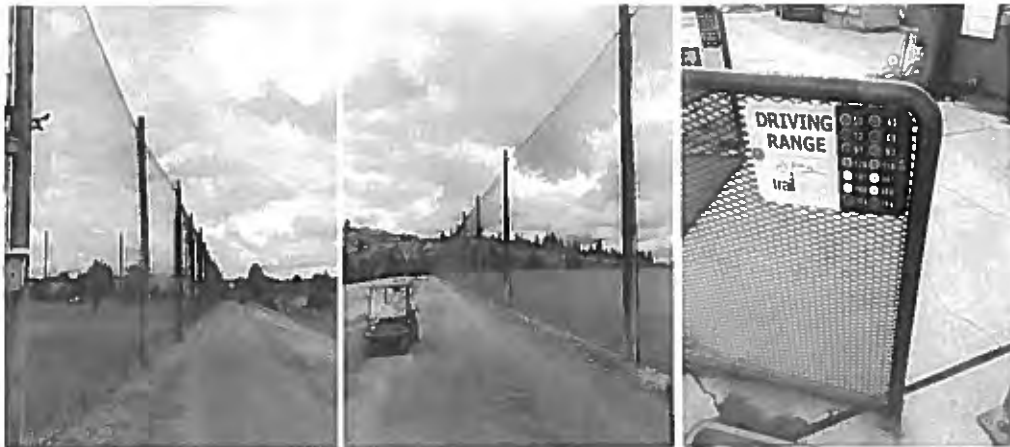
2. The back fencing is too low for the length of the driving range allowing balls to clear the fencing. This causes problems due to the location of the community garden as well as a grassy area for the public to enjoy. There are also homes that have been damaged in the past.

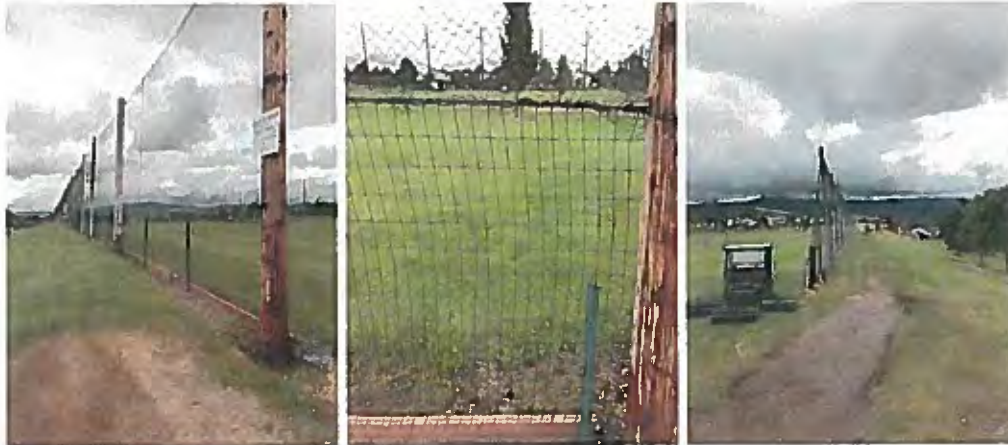
3. The fencing located on the right side of the driving range is lower than the fencing on the left side and the rear section. Located on this side of the driving range is the fairway to the golf course. There are multiple balls being hit over this fence daily. The fencing on this side is aged and has been damaged in the past. A section has been replaced, however, the newer fencing has openings that are too large and can allow golf balls to pass through the openings.
